The fire resistance performance of an uninsulated garbage chute doorset when tested in accordance with BS 476: Part 22: 1987, Clause 8.

326520

RNB Engineering Limited
Unit 16,
Highams Lodge Business Centre,
Blackhorse Lane,
London.
E17 6SH

29th April 2013

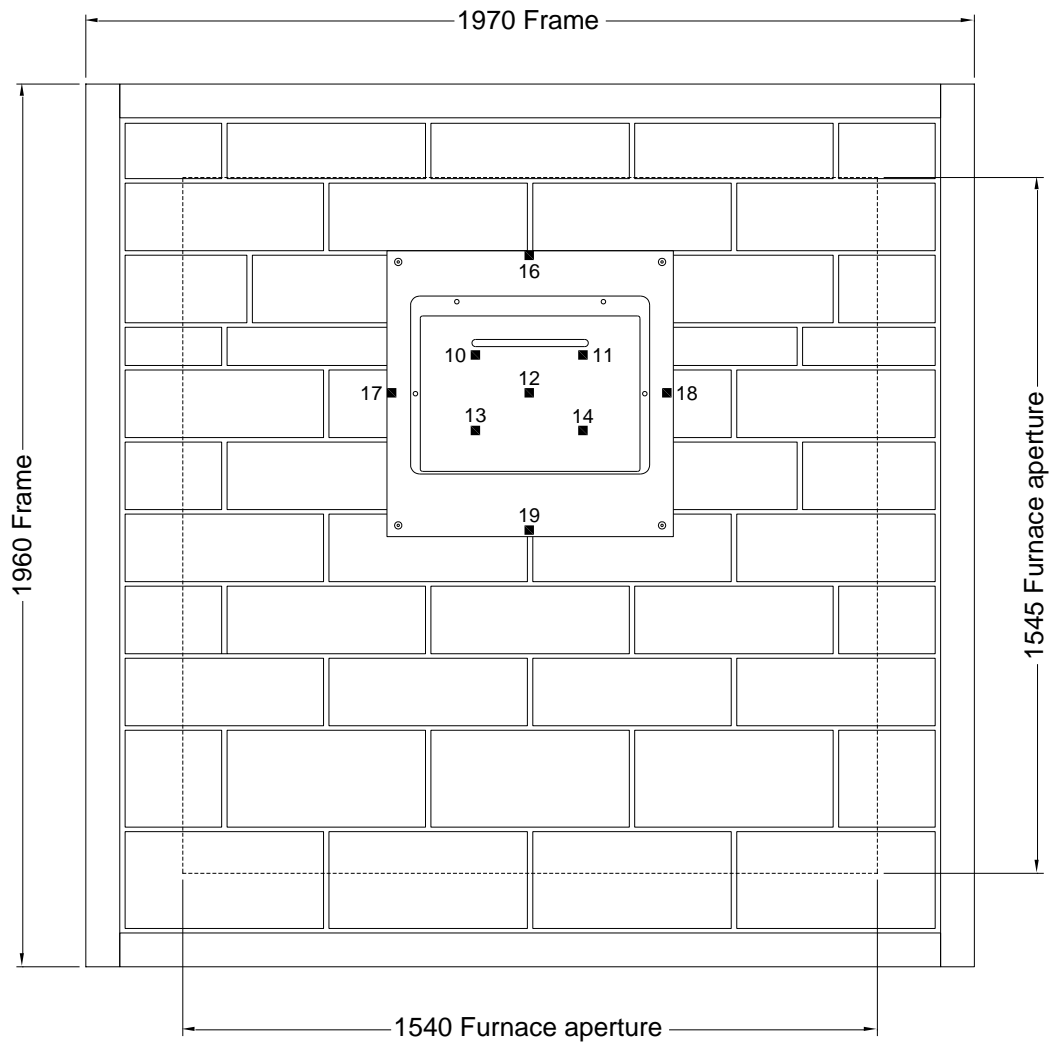
Figure 1- General Elevation of Test Specimen

■ Positions of thermocouples

General	The instrumentation was provided in accordance with the requirements of the Standard.
Furnace	The furnace was controlled so that its mean temperature complied with the requirements of BS 476: Part 20: 1987, Clause 3.1. using six mineral insulated thermocouples distributed over a plane 100 mm from the surface of the test construction.
Thermocouple Allocation	Thermocouples were provided to monitor the unexposed surface of the specimens. The output of all instrumentation was recorded at no less than one minute intervals as follows:
Thermocouples 10 to 14	At five positions on the unexposed surface of the doorset, one approximately at the centre and one at approximately the centre of each quarter section of the doorset.
Thermocouples 16 to 19	At four positions on the unexposed surface of the frame, one at the approximate mid-height/span of each of the frame members. The locations and reference numbers of the various unexposed surface thermocouples are shown in Figure 1.

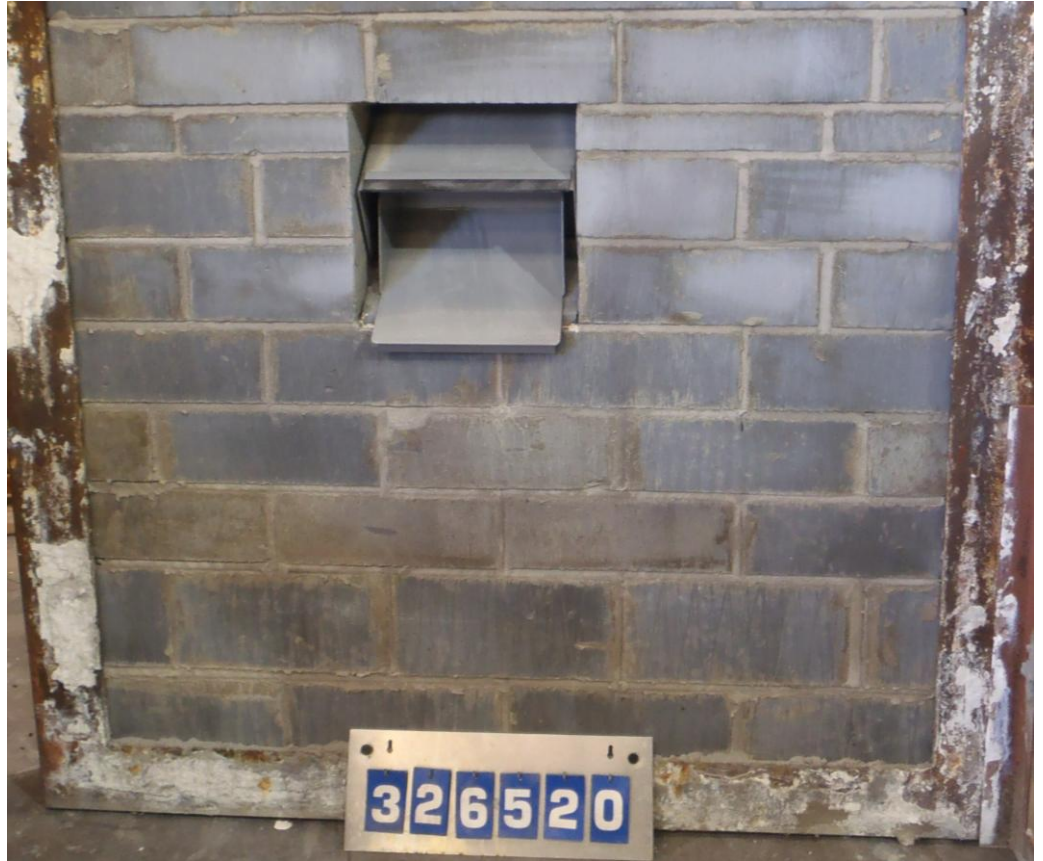
The exposed face of the specimen prior to testing

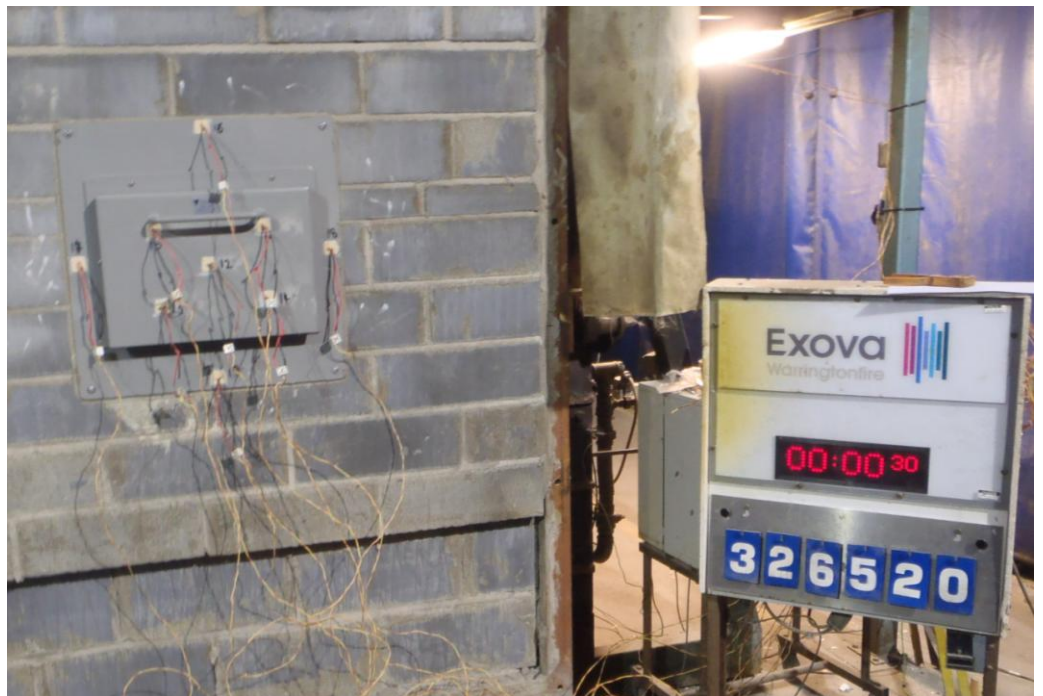
The unexposed face of the specimen prior to testing

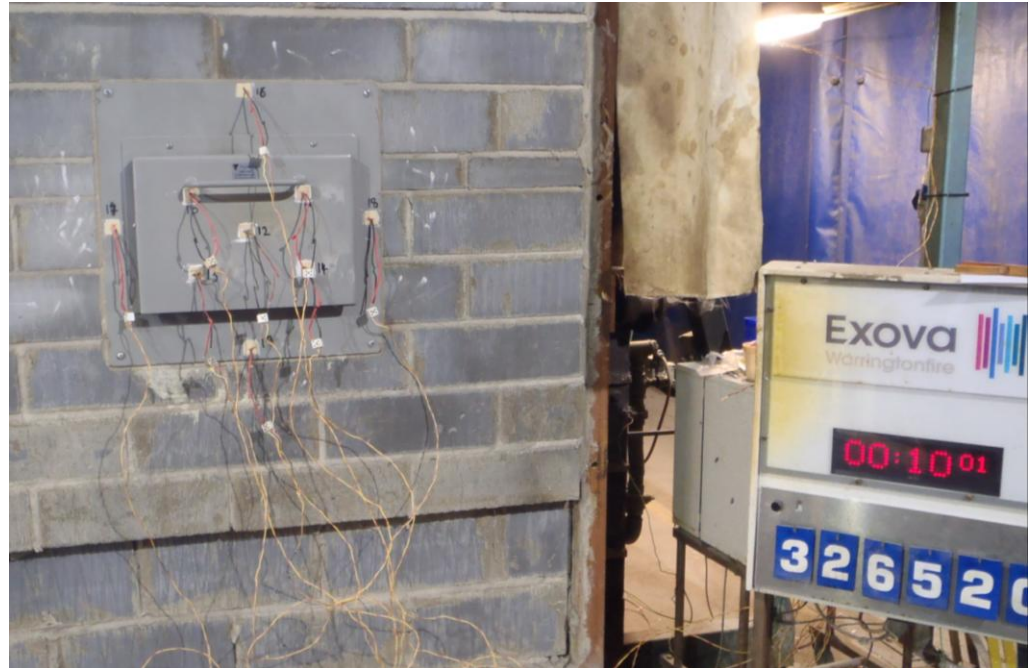
The unexposed face of the specimen after 10 minutes of testing

Time		All observations are from the unexposed face unless noted otherwise.
Mins	secs	The ambient air temperature in the vicinity of the test construction was 11°C at the start of the test with a maximum variation of +6°C during the test.
00	00	The test commences.
06	32	Slight flaming visible on the exposed face of the chute.
08	31	Slight smoke release visible around the chute.
10	00	The centre of the chute door starts to discolour.
20	00	The centre of chute door continues to discolour; the frame just above the chute door has also discoloured at mid-span.
26	08	The paint finish starts to blister at the centre of chute door and is starting to crack and peel away.
30	00	The specimen continues to satisfy the integrity criteria of the test.
47	08	Intermittent flaming seen at the top edge of the chute door.
49	27	Intermittent flaming continues.
54	35	The intermittent flaming has subsided.
63	36	A small gap is opening up between the base plate and sub-frame above the top of the chute door (mid-span). No through gap is evident.

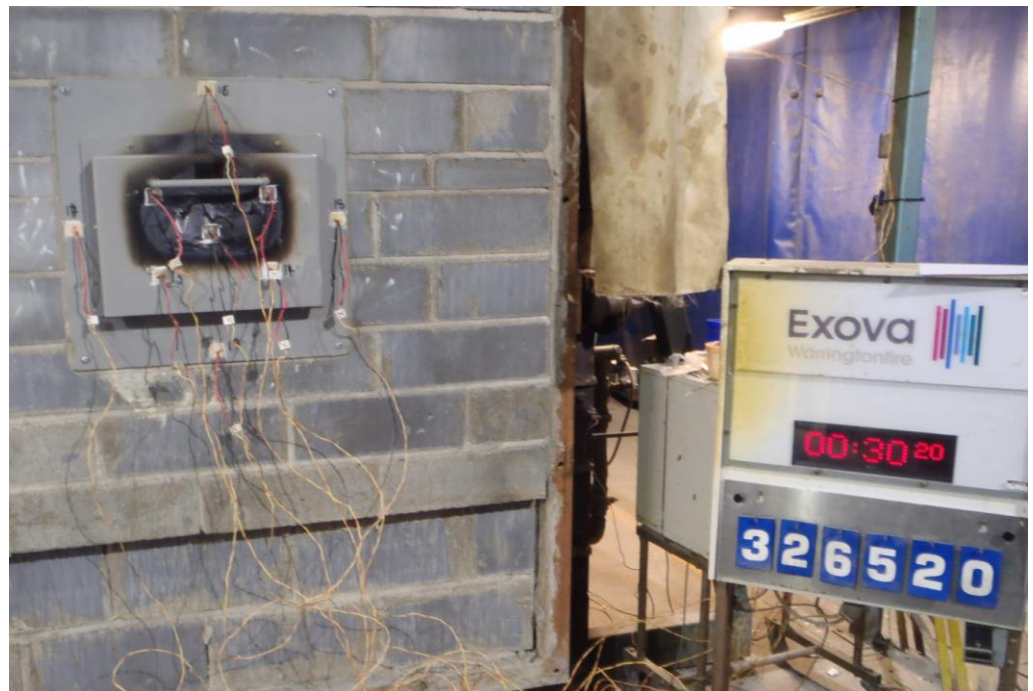
The unexposed face of the specimen after 30 minutes of testing

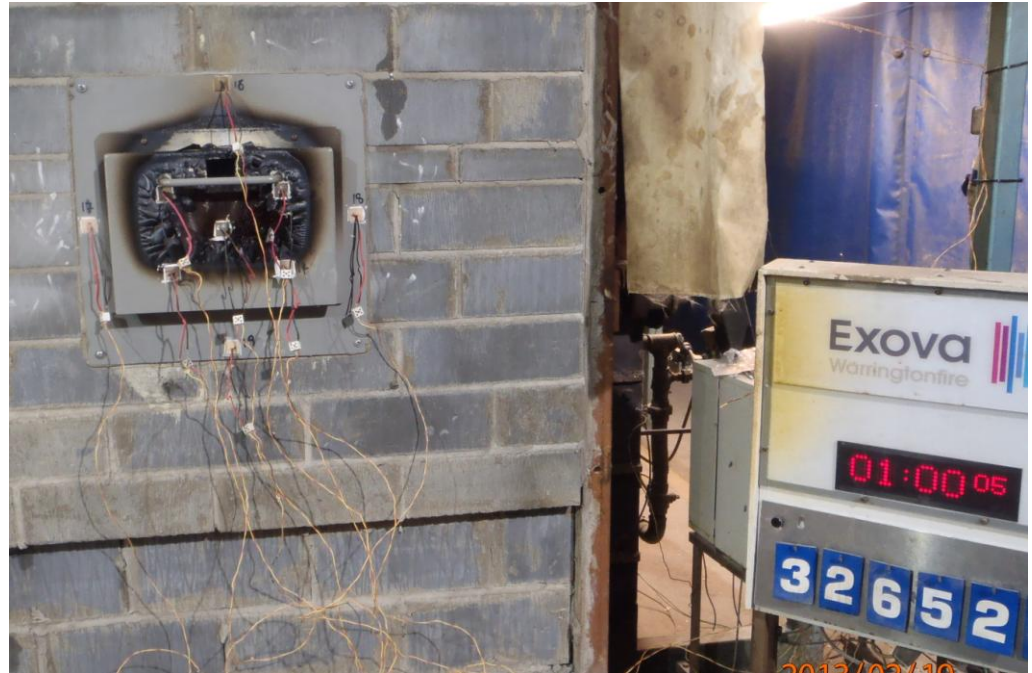
The unexposed face of the specimen after 60 minutes of testing

72	55	The base plate bows away from the wall at mid-span in between its fixings.
80	00	Slight smoke release now visible from the bottom edge of the chute door.
90	00	The chute door glows a dull red. Paint peels away from the chute door, the Sub-frame and base plate discolour black.
120	00	A gap has developed between the base plate and wall; however, it's not possible to get a gap gauge to penetrate into the furnace through this gap.
150	00	The paint finish continues to peel away and discolour from around the top 2/3 of the chute assembly.
180	00	No significant visible change.
240	00	The specimen continues to satisfy the integrity criteria of the test.
264	00	No significant visible change. The test is discontinued at the request of the sponsor.

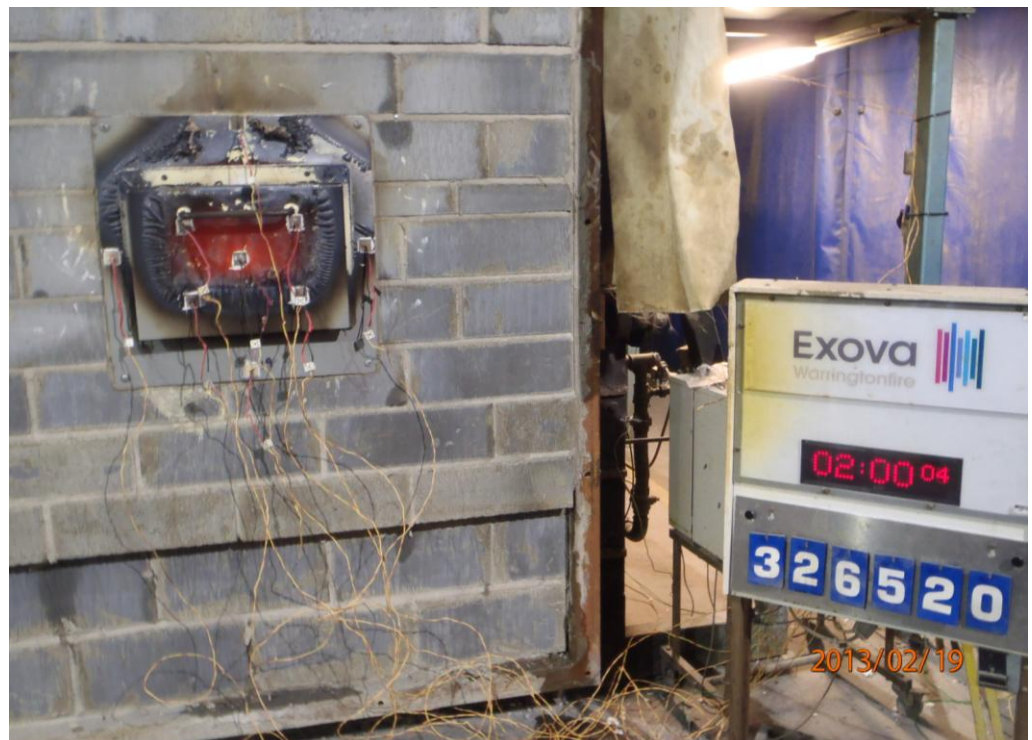
The unexposed face of the specimen after 120 minutes of testing

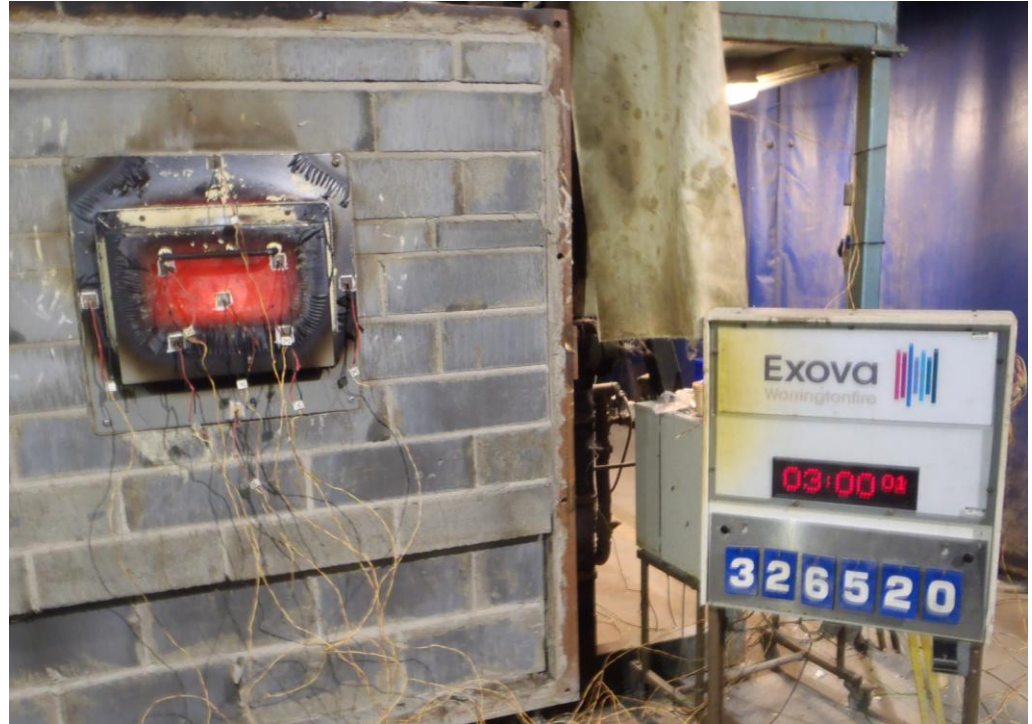
The unexposed face of the specimen after 180 minutes of testing

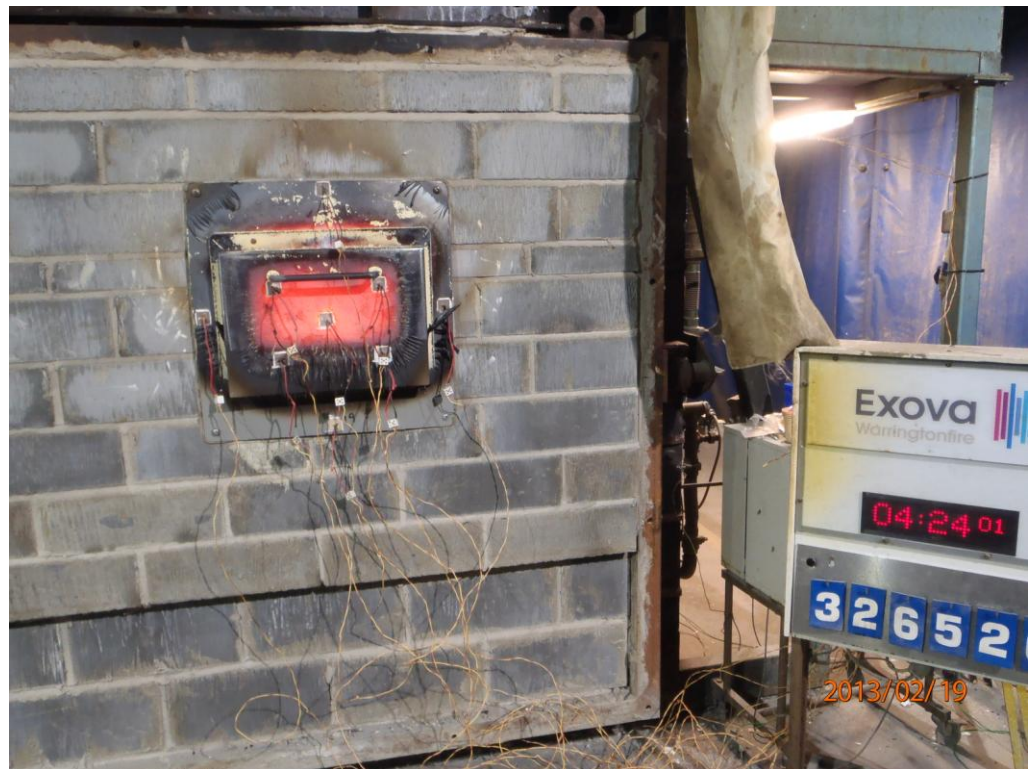
The unexposed face of the specimen after 264 minutes of testing

Integrity It is required that there is no collapse of the specimen, no sustained flaming on the unexposed surface and no loss of impermeability. These requirements were satisfied for a period of 264 minutes after which the test was discontinued.

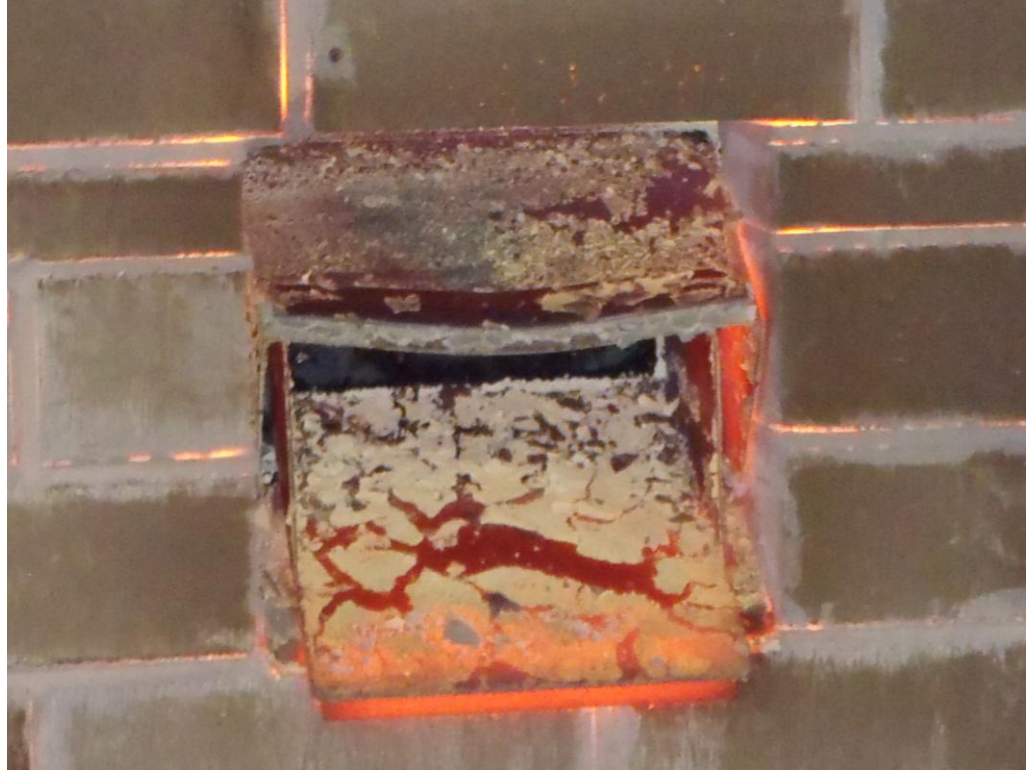
The exposed face
of the specimen
immediately after
test.

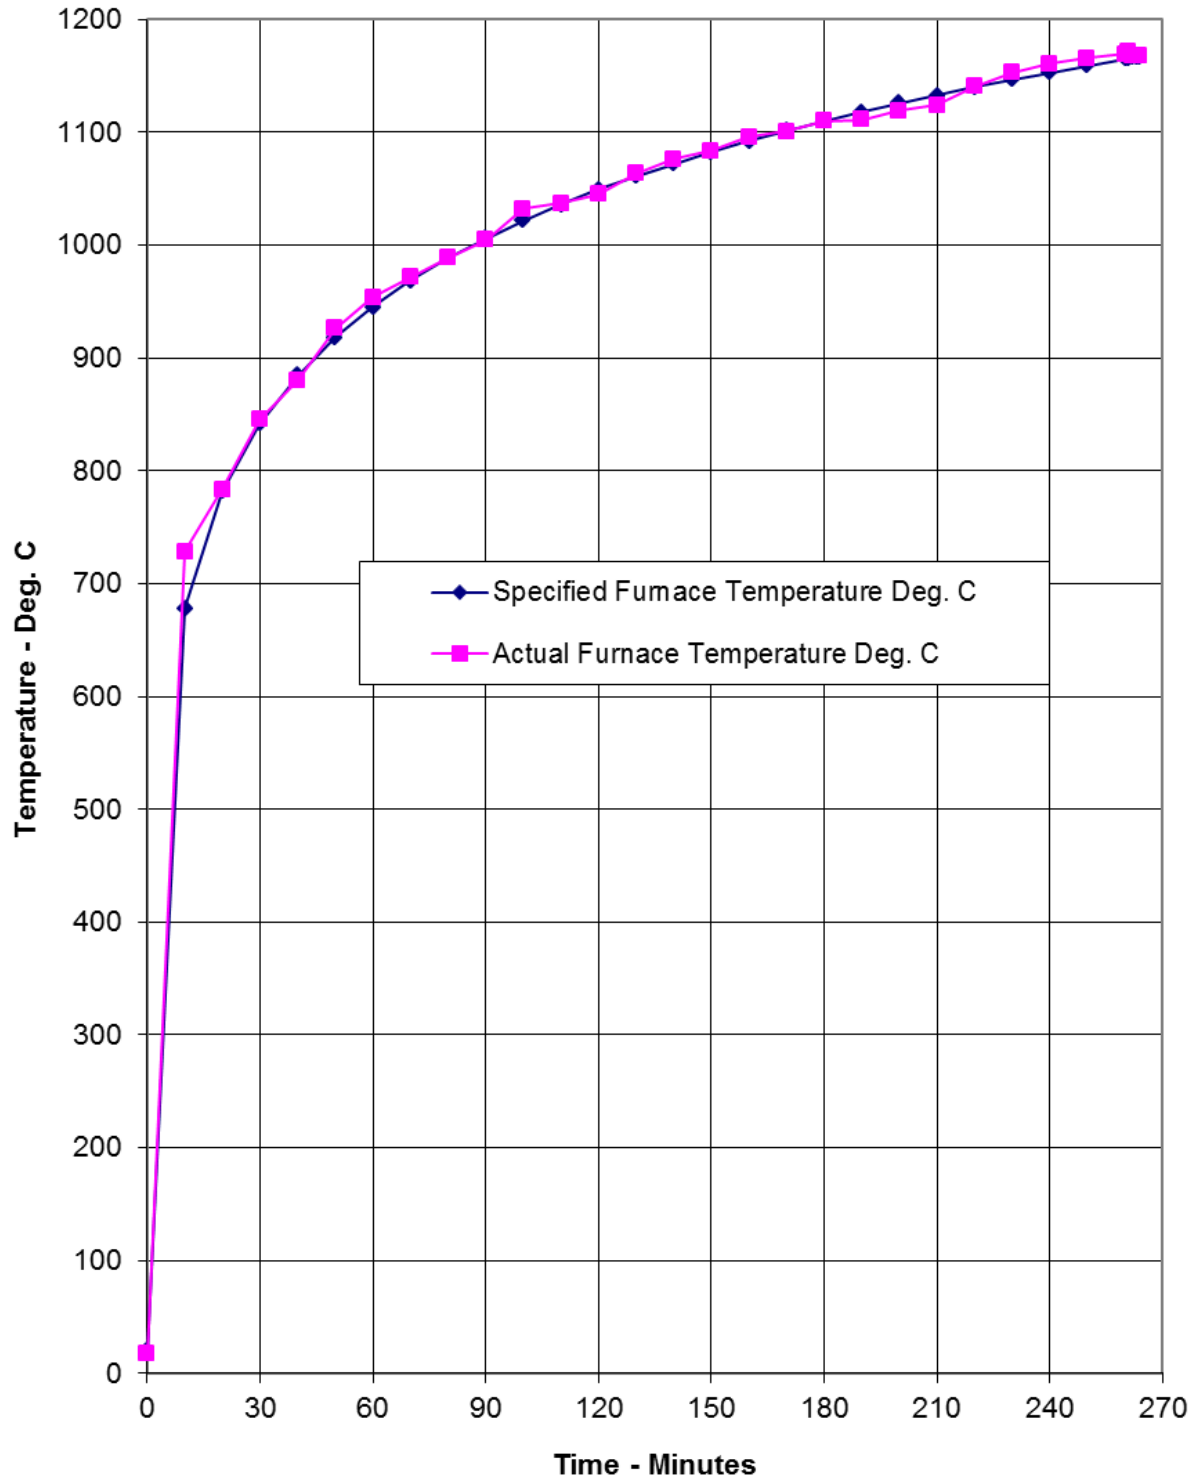
Graph Showing Mean Furnace Temperature, Together With The Temperature/Time Relationship Specified In The Standard

Mean Furnace Temperature, Together With The Temperature/Time Relationship Specified In The Standard

Time Mins	Specified Furnace Temperature Deg. C	Actual Furnace Temperature Deg. C
0	20	17
10	678	729
20	781	784
30	842	845
40	885	880
50	918	926
60	945	954
70	968	971
80	988	989
90	1006	1004
100	1022	1032
110	1036	1037
120	1049	1045
130	1061	1064
140	1072	1076
150	1082	1084
160	1092	1096
170	1101	1101
180	1110	1110
190	1118	1111
200	1126	1119
210	1133	1124
220	1140	1140
230	1146	1153
240	1153	1161
250	1159	1166
260	1165	1169
261	1165	1172
262	1166	1168
263	1167	1167
264	1167	1168

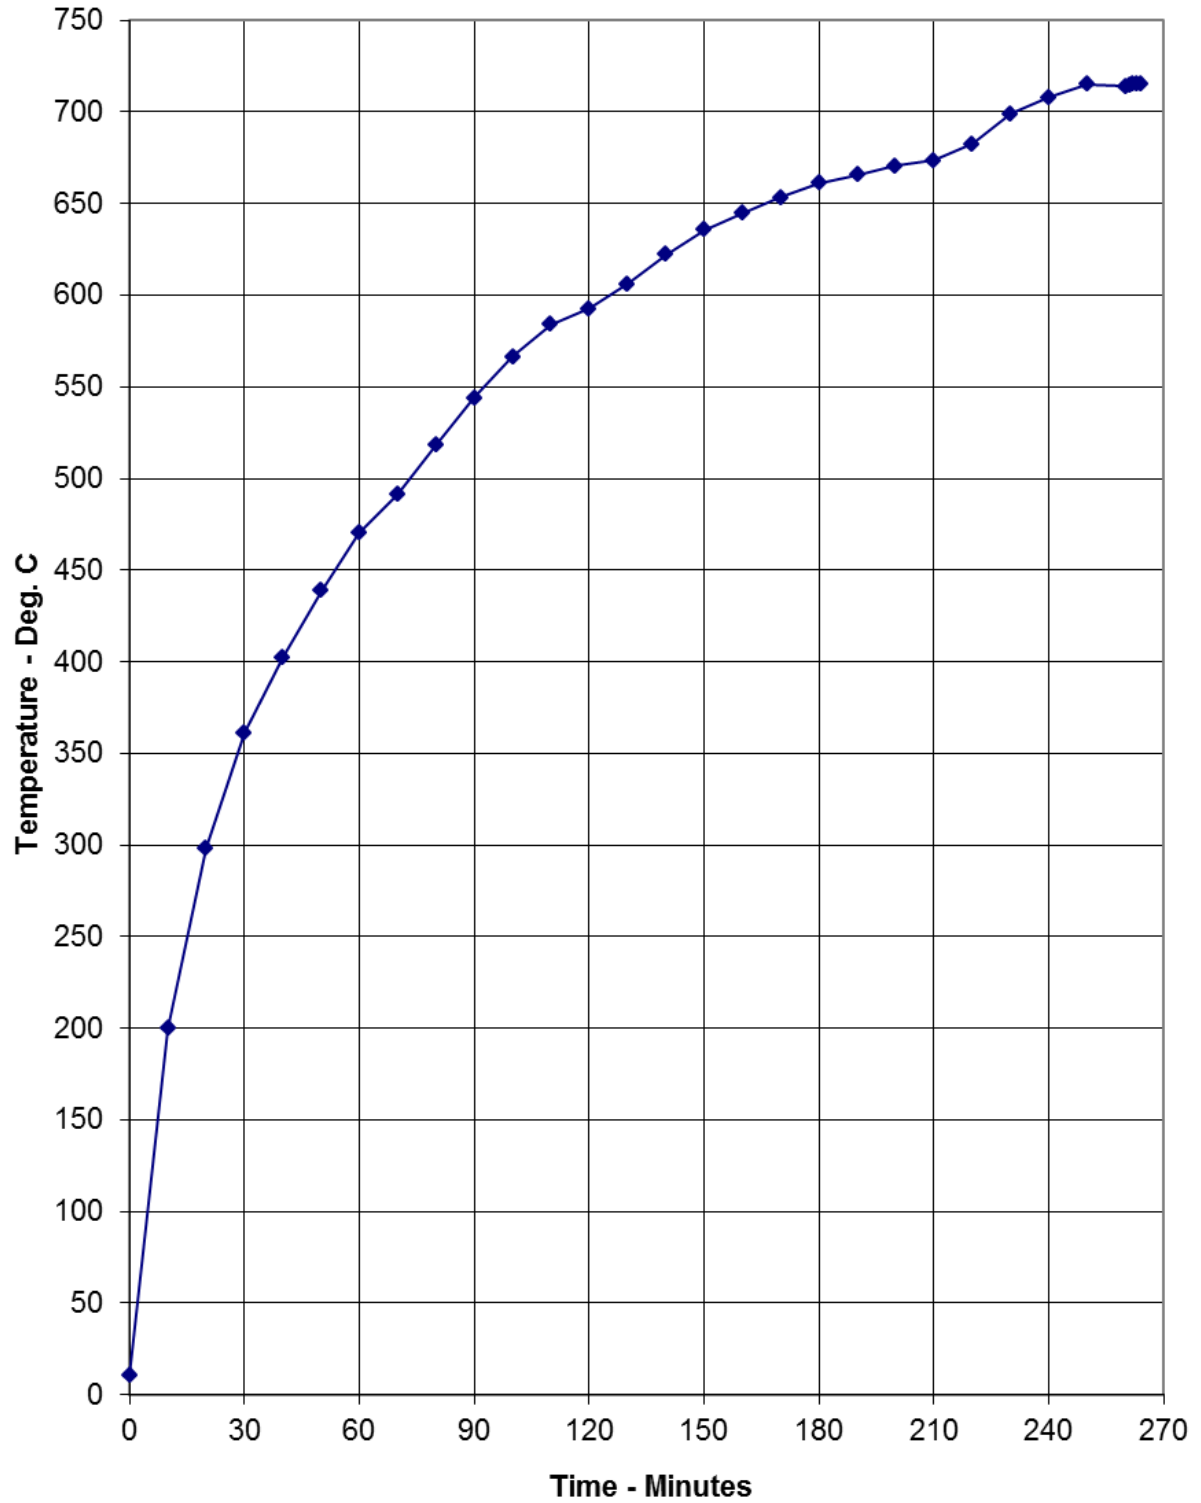
Graph Showing Mean Temperature Recorded On The Unexposed Surface Of The Specimen

Individual And Mean Temperatures Recorded On The Unexposed Surface Of The Chute

Time Mins	T/C Number 10 Deg. C	T/C Number 11 Deg. C	T/C Number 12 Deg. C	T/C Number 13 Deg. C	T/C Number 14 Deg. C	Mean Temp Deg. C
0	12	10	11	10	10	11
10	225	236	302	111	125	200
20	333	335	412	204	208	298
30	399	402	496	255	255	361
40	448	444	547	286	287	402
50	489	493	581	315	316	439
60	537	518	612	339	346	470
70	556	532	640	361	368	491
80	578	570	670	382	391	518
90	600	597	697	407	420	544
100	623	619	722	428	440	566
110	640	639	740	445	457	584
120	649	648	750	452	465	593
130	663	663	767	462	476	606
140	681	680	784	475	491	622
150	694	696	799	487	503	636
160	703	706	809	494	512	645
170	711	715	819	502	519	653
180	721	724	826	510	526	661
190	727	730	830	514	528	666
200	732	737	836	516	532	671
210	738	743	839	516	531	673
220	748	754	850	523	538	683
230	764	773	868	535	555	699
240	767	781	875	550	568	708
250	773	788	880	558	576	715
260	773	789	881	556	571	714
261	773	789	882	556	571	714
262	774	791	883	556	571	715
263	775	790	883	556	572	715
